Technical Report CERC-95-3
March 1995

Periodic Inspection of Cleveland Harbor East Breakwater, Ohio

Report 1 Base Conditions

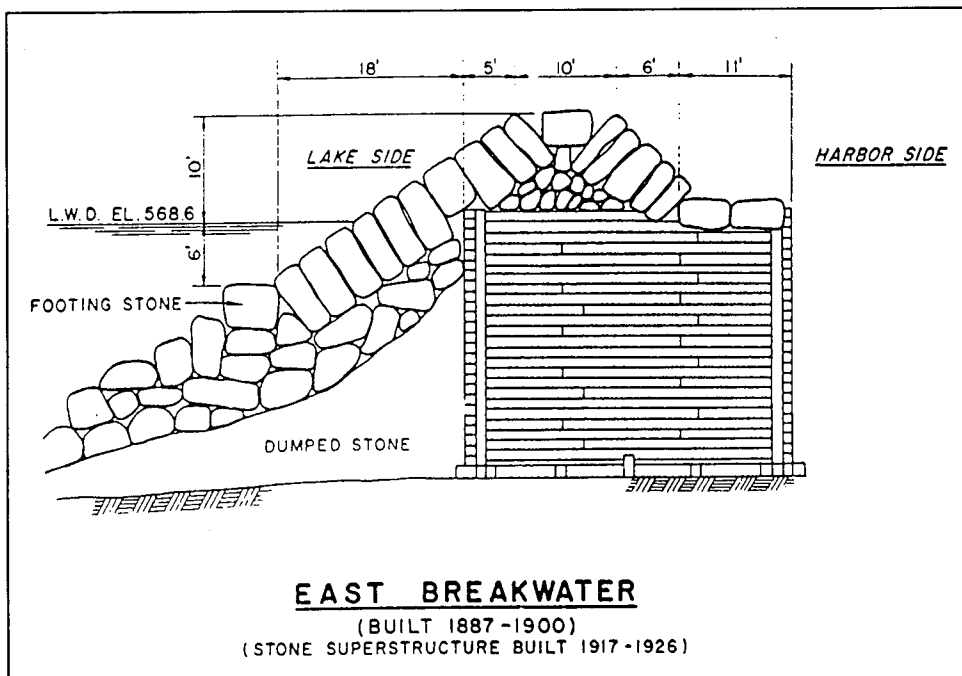
Figure 4. Cross section of western 3,000-ft portion of Cleveland Harbor east breakwater

The length of the existing east breakwater is 6,392 m (20,970 ft). The westerly 914-m-long (3,000-ft-long) portion was constructed between 1887 and 1900, and was composed of a stone-filled timber crib structure with a concrete cap. During the period 1917-1926, a stone superstructure, including a sloping stone armoring, was placed on the lakeward side (Figure 4). The easterly 5,477 m (17,970 ft) portion was constructed between 1903 and 1915 and

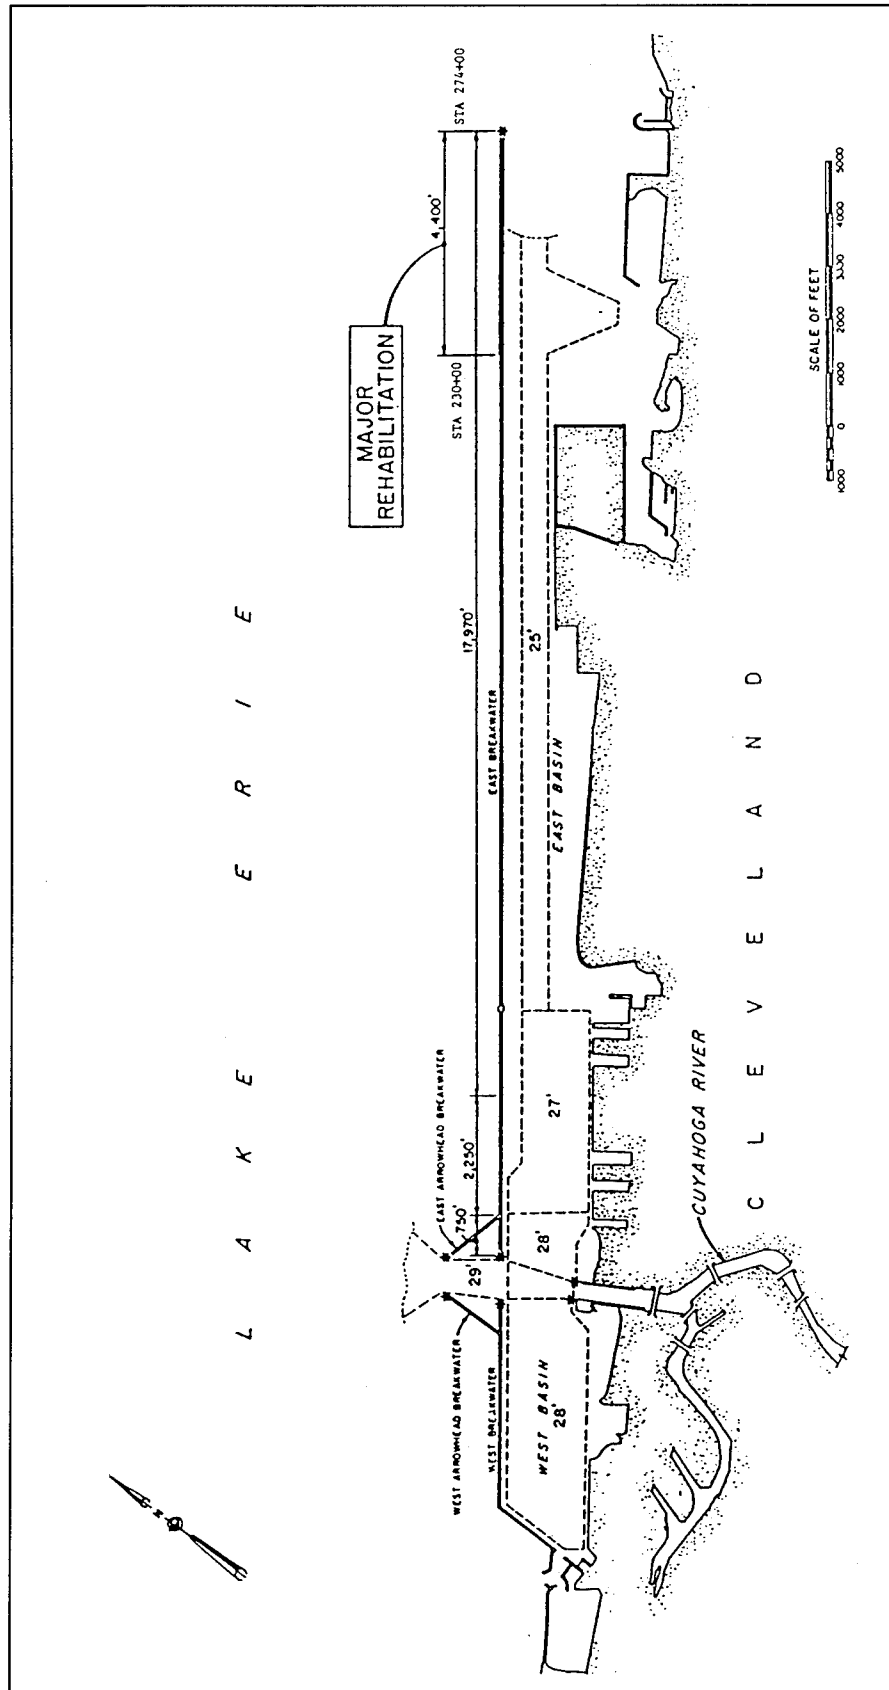
Figure 6. Major rehabilitation of east breakwater completed in 1979

A major rehabilitation project involving the easterly 1,341 m (4,400 ft) of the east breakwater was completed in 1979 (Figure 6). It involved repairing the structure with dolos concrete armor units. The lakeward slope, and in some areas the crest, were rebuilt using 1,814 kg (2-ton) dolos placed on a 1V:2H slope on the breakwater trunk. A typical section of the rehabilitated breakwater trunk is shown in Figure 7. The east head involved a section similar to the trunk but the slope was constructed on a 1V:2.5H to maintain stability. More information on the design of the dolos rehabilitation can be obtained from U.S. Army Engineer District, Buffalo (1979). The rehabilitated dolos section was monitored under the MCCC program and is discussed in Chapter 2. Additional dolosse were placed on the head section in 1982 and 1987 to repair storm damages.
